Pen Test Partners

6.5. HWA-M4: System Not Appropriately Hardened

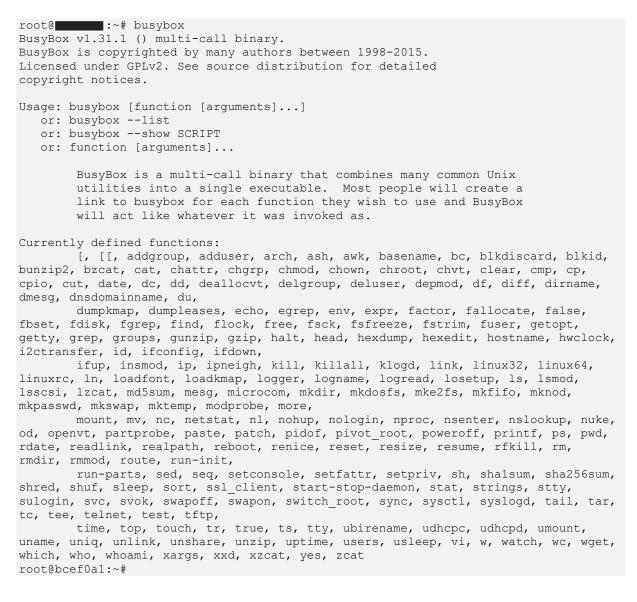
Firstly, the device was running a default instance of BusyBox which included all functions, a large amount of which were not required for maintenance of the device. It is common to remove any functions that are not required to provide a smaller attack surface on the device.

It is recommended that all unnecessary binaries are removed from the device and security properties are applied where possible.
